**WORKSHOP WITH PLANT WALKDOWN IN  
TEMELIN, UNDER THE CZECH-AUSTRIAN  
BILATERAL AGREEMENT  
SEPTEMBER 26/27, 2006**

Report – Final Version

December 29, 2006

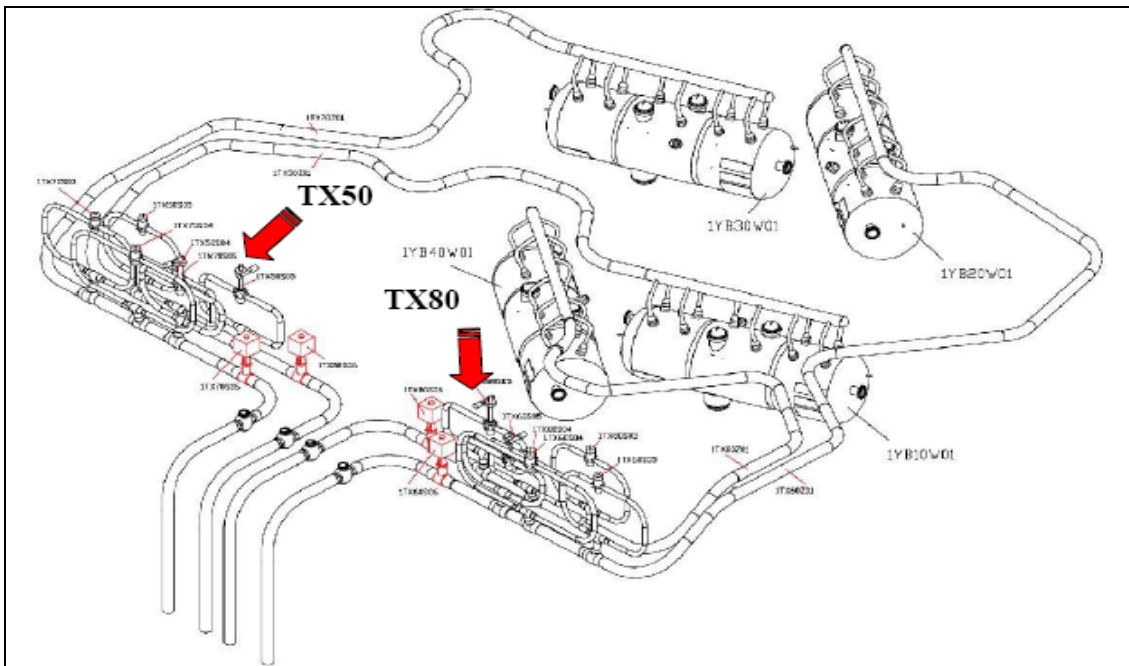
**Fig. 1.1:** Main steam lines with steam generators, bubliks and valves (presentation “Improvement in A820 Compartment”, see Appendix 1 for full reference)

In the conclusions of IAM it was stressed that no flaws occurred and no damage was caused by the 46 Hz vibrations to the safety valves or to the piping. This situation is also known from the other WWER-1000 plants visited by the team of IAM investigating the Temelín issue.

The current situation, with **vibrations** on one of the lines at the acceptable limits, would require a very detailed ISI regime to be put in action in order to record possible early damage to the piping, the joints and the valves. This is particularly important since the ASME code requirements are held up as providing the limitations on the steady state usage of the components.

Permanent vibration monitoring should be recommended in order to detect changes in the system long before a crack can be found by conventional NDT methods.

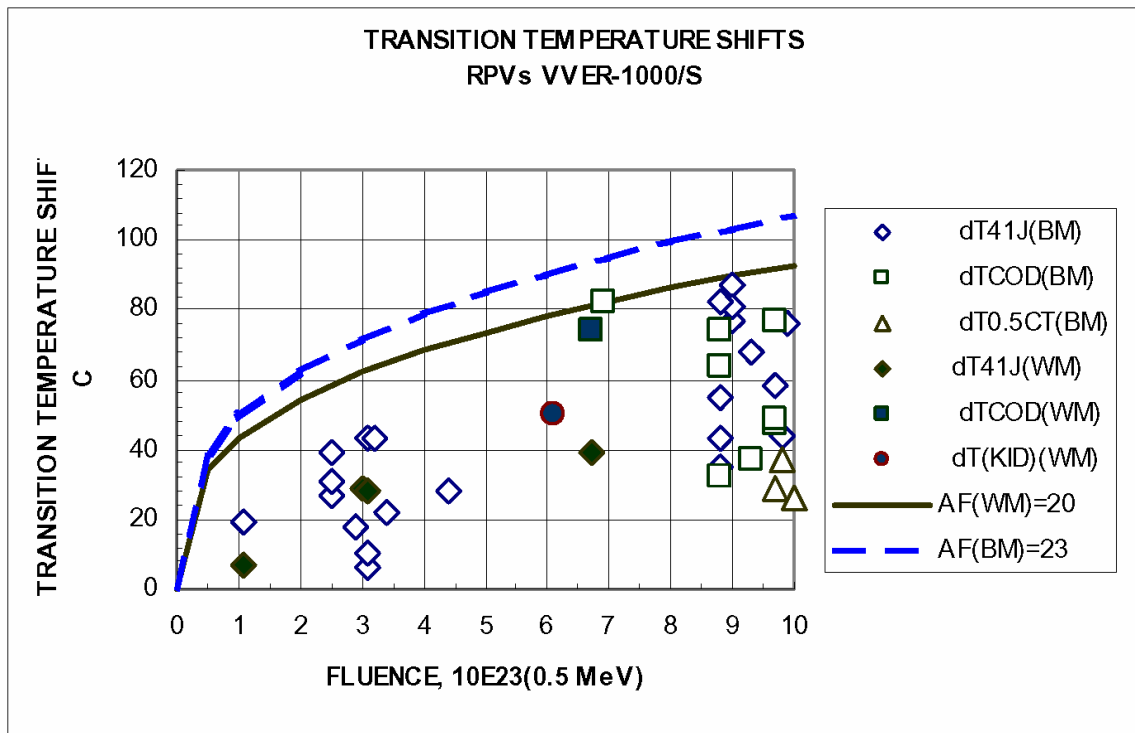
The Czech presentation included “preliminary irradiation results” from material irradiated in a test reactor (fig. 2.1). The answer to questions of the Austrian experts’ team with respect to the materials irradiated within this program indicated that the irradiated samples were manufactured from acceptance test materials.

**Fig. 2.1:** Preliminary results of RPV Temelin 1 + 2 (presentation “Surveillance Programme”, see Appendix 1 for full reference)

The Austrian team of experts recommends to gain access to information on the embrittlement development sufficiently detailed for evaluation. The notification about material properties as determined experimentally in the surveillance programme is of high importance in order to verify the compliance of material properties to the code specifications.

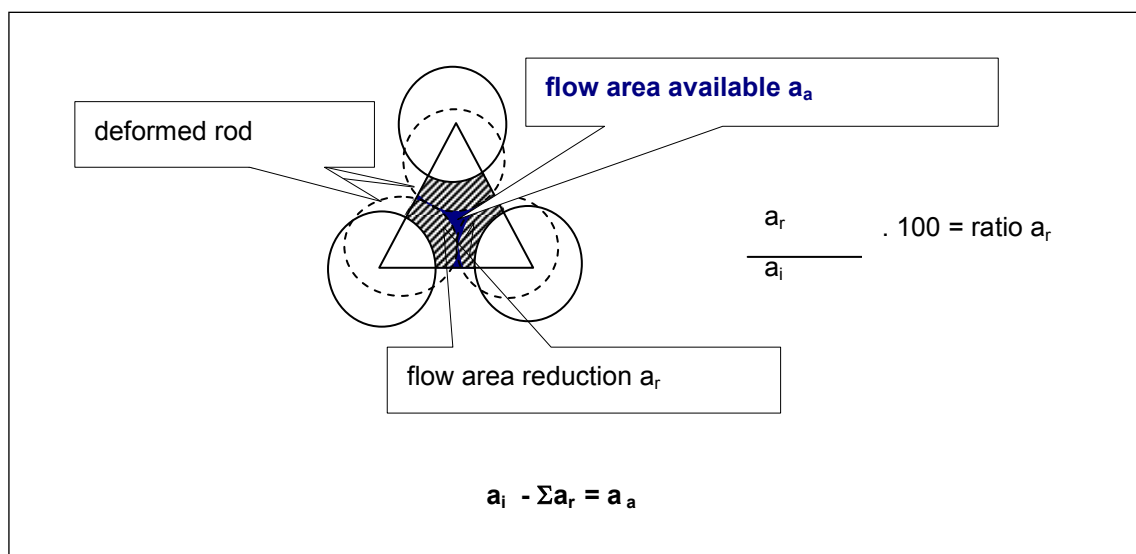
There are open questions regarding the details of the factual limiting conditions of FR deformation, and how those conditions can be verified for the requalification of the fuel elements for further service:

- Does the permissible state of the FRs signify an arrangement as shown below in its cross-sectional representation? Or is the touching zone formed by just two adjacent FRs?

- How would, in both cases, this touching zone extend between two adjacent spacers?
- How does this representation relate to the statement of the Czech side “... *the conservative assumption that the FRs could touch each other*”?
- What are the limits imposed on the axial extent of the touching zone?

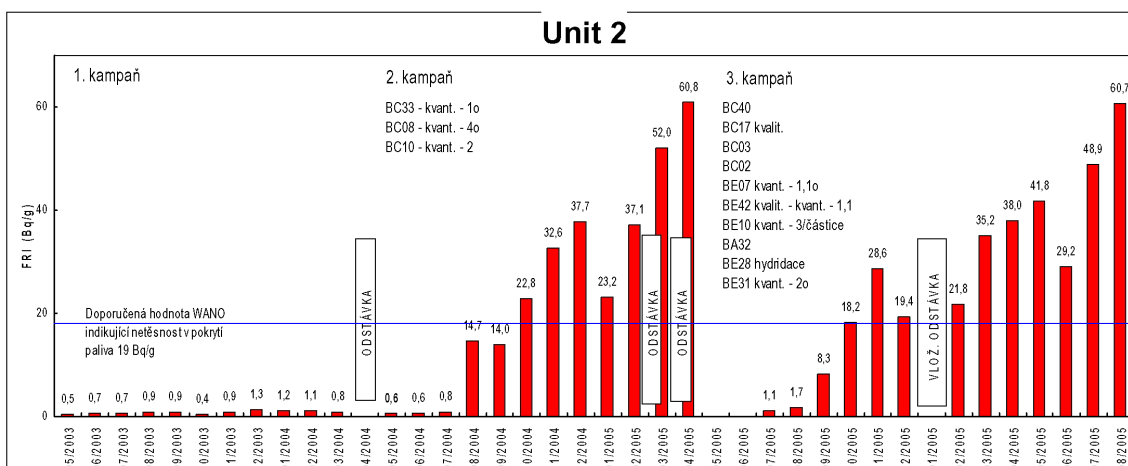
**Causes of problem:** The extended in-service period of the Westinghouse fuel could be part of the problem, but also fretting of the grid-spacers.

**Fig. 7.1:** Fuel failure history at Unit 2 developing over 3 campaigns, compared to WANO qualification criterion (presentation, see Appendix 1 for full reference)

It can be seen from Fig. 7.1 that the number of leaky assemblies, identified and removed from the core during refuelling, is increasing with the number of fuel cycles.

**Counter-measures:** Removal of the failed fuel rods and the replacement by solid stainless steel rods appears to be the practice to deal with the problem. This is an adequate procedure.
