NPP Paks II

K. Decker
E. Hintersberger

**Paleoseismological assessment of the Siting Report
and the Site License with respect to fault capability**

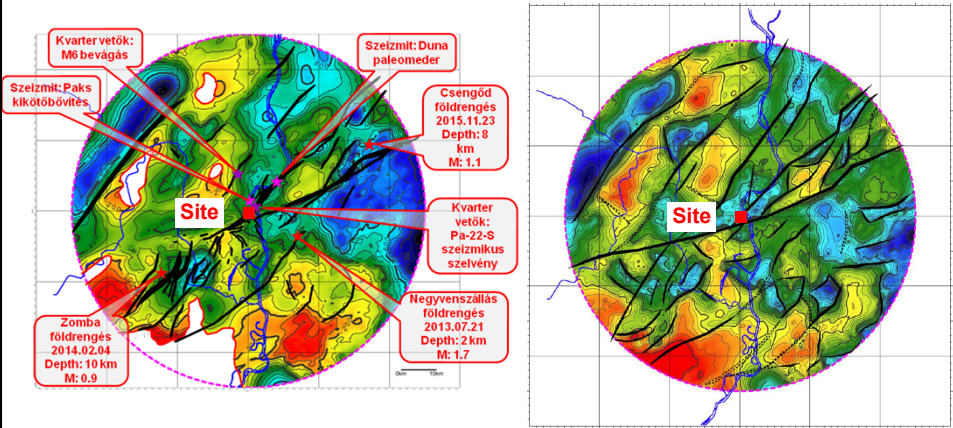
Geological Site Report, Tóth et al., 2016, Fig. 57

Data proofing active (Quaternary) deformation of the Dunaszentgyörgy-Harta fault zone summarized in the Geological Site Report are not fully reflected in the Site Safety Report.

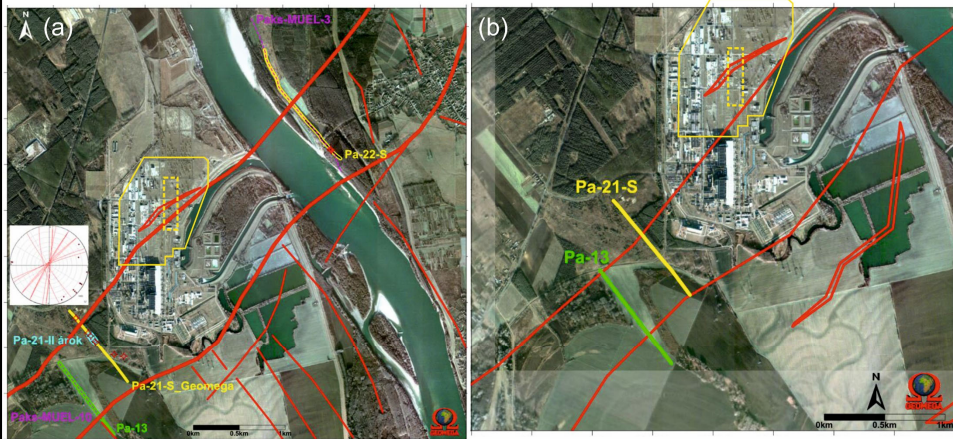
Geological Site Report, Ács et al., 2016, Fig. 418

The fault zone indicated by Geological Site Report (left) extends farther North into the perimeter of the new reactor blocks (indicated by broken yellow line).

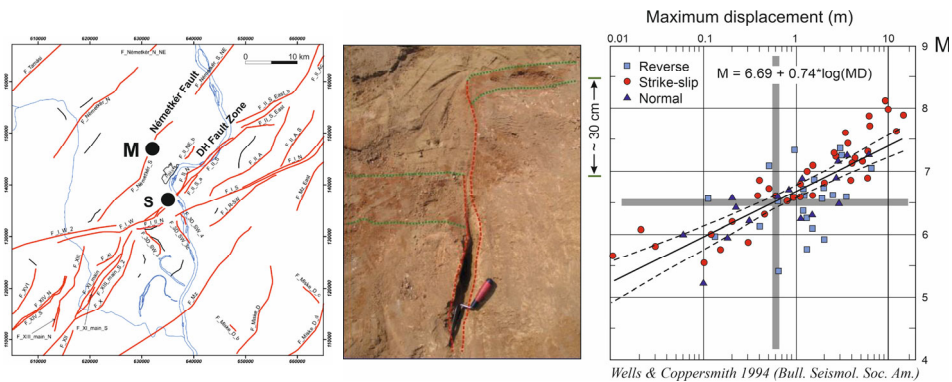
(A) Location of the paleoseismological outcrops along Highway M-6 (Magyari, 2016). Background map: MVM Paks II Zrt., 2016b, Fig. 5.2.1.2.6-3.

(B) Buried fault scarp with ca. 30 cm vertical offset of a red paleosol developed in loess (green lines; Magyari, 2016, Figure 5).

(C) Empirical correlation between surface displacement and earthquake magnitude. Grey bar denotes the surface displacement of 30 cm inferred from (A).

The paleoseismological results obtained from outcrops along Highway M-6 are not reported in MVM Paks II Zrt. (2016a).

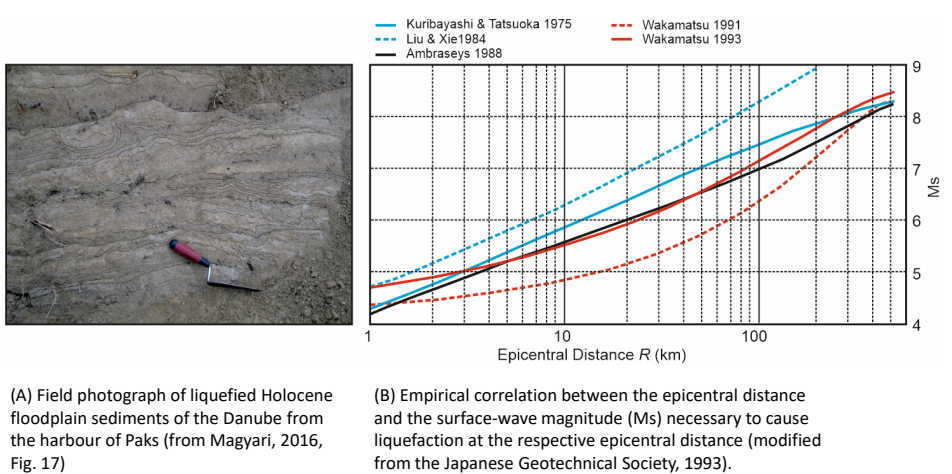
(A) Field photograph of liquefied Holocene floodplain sediments of the Danube from the harbour of Paks (from Magyari, 2016, Fig. 17)

(B) Empirical correlation between the epicentral distance and the surface-wave magnitude (Ms) necessary to cause liquefaction at the respective epicentral distance (modified from the Japanese Geotechnical Society, 1993).

The paleoseismological results obtained from the harbor of Paks are not reported in MVM Paks II Zrt. (2016a).

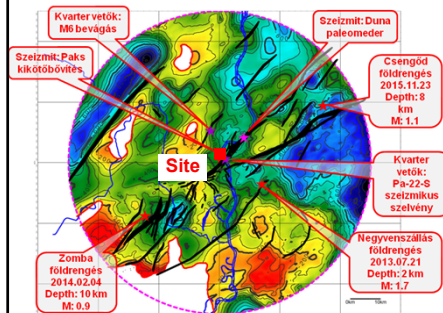
Geological Site Report, Tóth et al., 2016, Fig. 57

"... The now extremely detailed data from the Paks area suggest that the Dunaszentgyörgy - Harta fault zone is a young and active tectonic element of the area. ... At the same time, it should be emphasized that even in this zone, which can be classified as tectonically active, no significant displacement has developed, that is, no impact on quaternary formations on site that are less than 100,000 years old in the form of a significant displacement."

The statement is not supported by data from the Geological Site Report. Data prove vertical offsets of Quaternary strata reaching up to several tens and even 100 m in the near-region of the site. The explicitly stated number of 100,000 years for the age of formations is not substantiated by data.

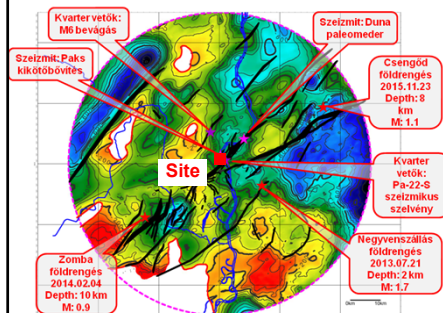
Geological Site Report, Tóth et al., 2016, Fig. 57

"The complex investigations confirm that at the investigated site and within at least 10 km of its surroundings, no fault segment exists that led to surface displacement by faulting in the last 100,000 years."

The statement is factually wrong. Data in the Geological Site Report prove four surface-breaking earthquakes within a distance of 10 km from the site. Two events with $M > 6$ with ages between 14,000 and 5,000 years were documented in outcrops along Highway M-6 (Magyari, 2016). Two other paleoearthquake ruptures with ages between ca. 19,000 and 20,000 years were documented in trench Pa-21-II next to the site.

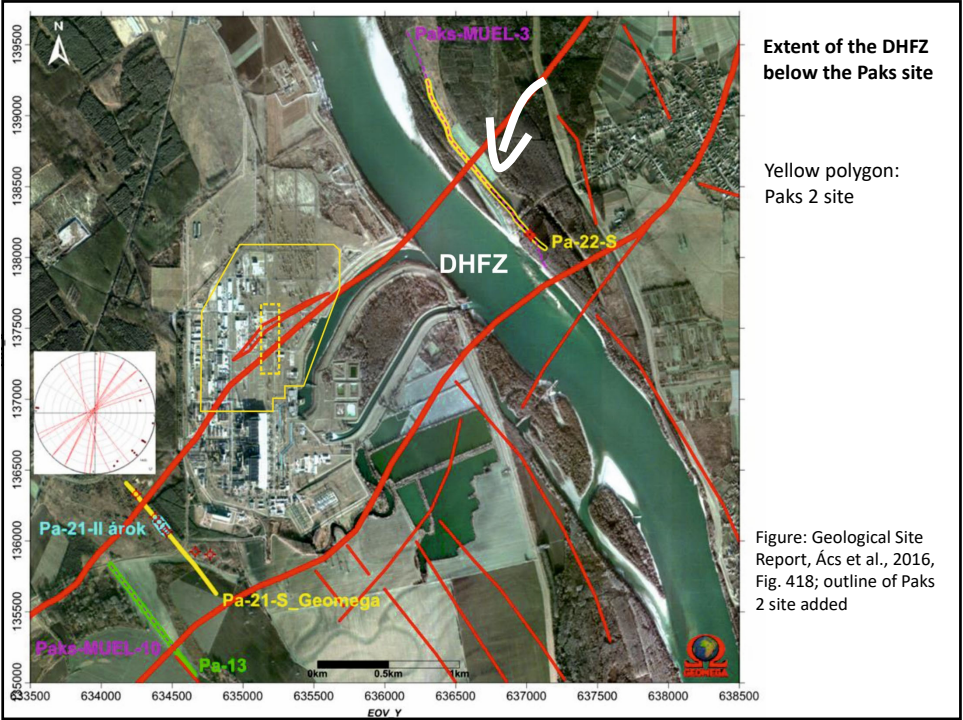
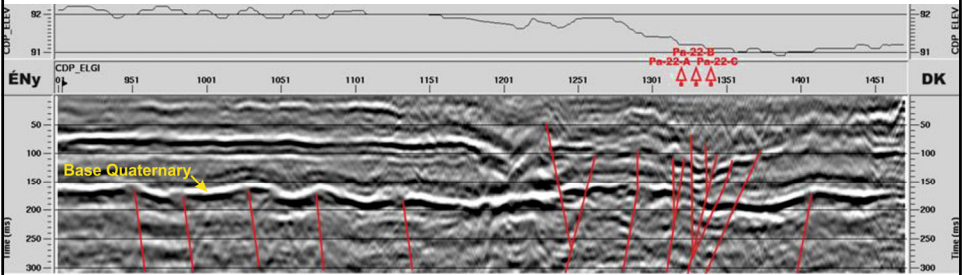
Seismic profile Pa-22-S across part of the DHFZ (1500 m NE of the site)

The profile shows 16 individual faults (indicated by the red lines) that offset even the youngest sediments of the Danube. Fault sticks are shown to reach up to about 50 ms TWT (about 5 to 10 m below surface assuming vs 200-400 m/s).

Geological Site Report and Site Safety Report do not contain paleoseismological data from the faults imaged by seismic (and resistivity) profiles.

Figure and data are not shown in the MVM Paks II Site Safety Report that formed the basis of the site license application.

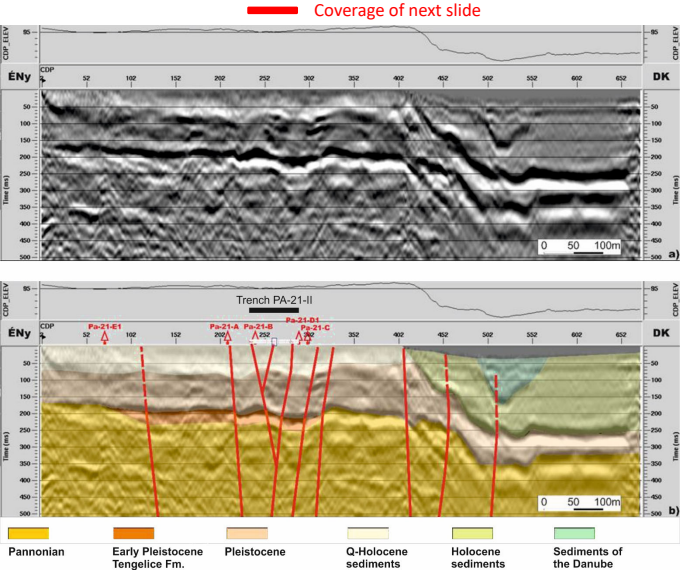
Seismic profile Pa-21-S across part of the DHFZ (700 m SE of the existing NPP Paks)

The profile shows 10 individual faults (indicated by the red lines) that offset even the youngest sediments of the Danube. These faults are shown to reach up to the surface.

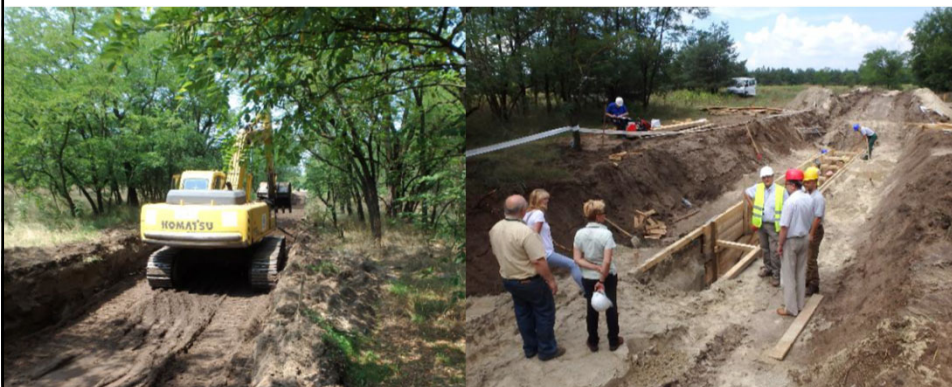
Trench Pa21-II ca. 700 m SE of the existing NPP

Paleoseismological assessment of a branch fault of the DHFZ in a 82 m long / 2.8 m deep excavation:

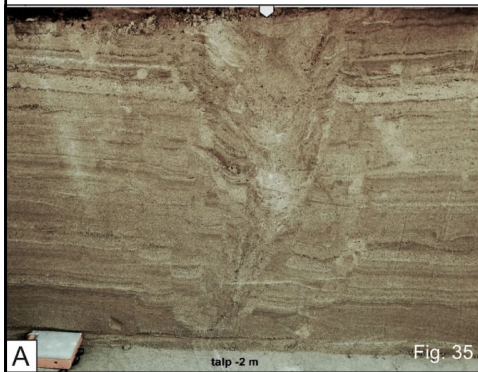
Trench Pa21-II ca. 700 m SE of the existing NPP

(A) depicts a surface breaking fault that disrupts and offsets about 19.000 to 20.000 years old flood sediments of the Danube.

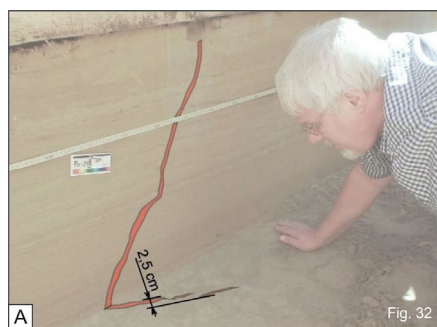
Figure: Geological Site Report,
Hálasz et al., 2016, Fig. 32

(A) Sediment filled en-échelon tension gashes erroneously interpreted to record sinistral slip and 2.5 cm horizontal displacement (from Hálasz et al., 2016, Fig. 32; Frank Horvath for scale).

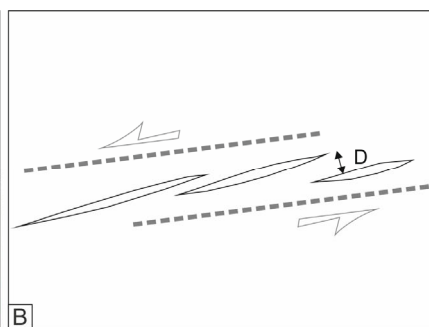
Figure: Decker & Hintersberger, 2021, Fig. 24

(B) schematic sketch of a sinistral shear zone with en-échelon tension gashes showing that the measurement in (A) measures the horizontal spacing of the sediment-filled tension gashes. The amount of sinistral displacement remains undetermined and may exceed the stated value significantly.

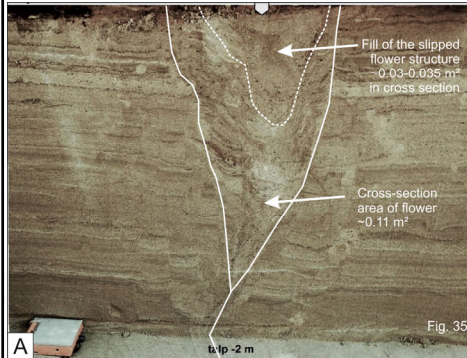
Background photo: Halász et al., 2016, Fig. 35

(A) Negative flower structure at 43.7 m of the trench Pa-21-II, interpretation by Decker & Hintersberger, 2021. The continuous white line indicates the boundary faults of the flower structure; the broken line delimits sediments of the post-tectonic fill.

The statement by MVM Paks II Zrt. is not in line with geological evidence described in the Geological Site Report. Interpreting the structures excavated in trench Pa-21-II as proofs of repetitive strong earthquakes with significant surface displacement is, at least, in the range of reasonable and scientifically defensible interpretations.

The occurrence of a permanent surface displacement can therefore not be reliably excluded by scientific evidences.

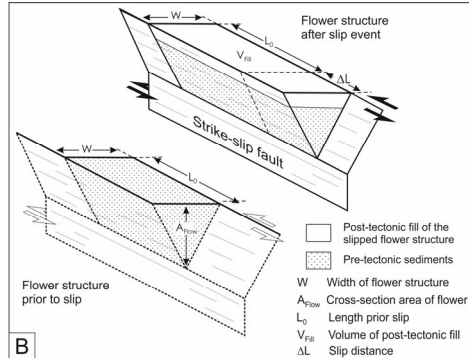
Figure: Decker & Hintersberger, 2021, Fig. 24

(B) Schematic shoebox model illustrating the geometry of a negative flower structure. A slip distance of 0.3-0.4 m is calculated from the dimension of the trenched structure (cross-section area 0.03 to 0.035 m²; minimum length 1.3 m; minimum volume of sediment fill 0.039 to 0.046 m³).
