NPP Paks II

K. Decker
E. Hintersberger

**Paleoseismological assessment of the Siting Report
and the Site License with respect to fault capability**

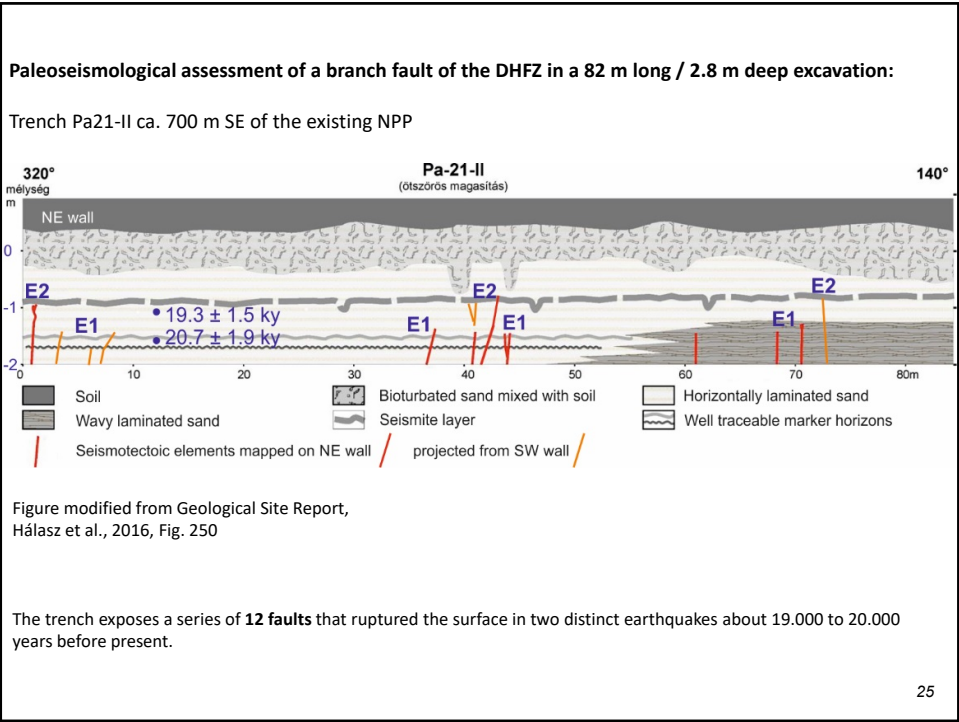
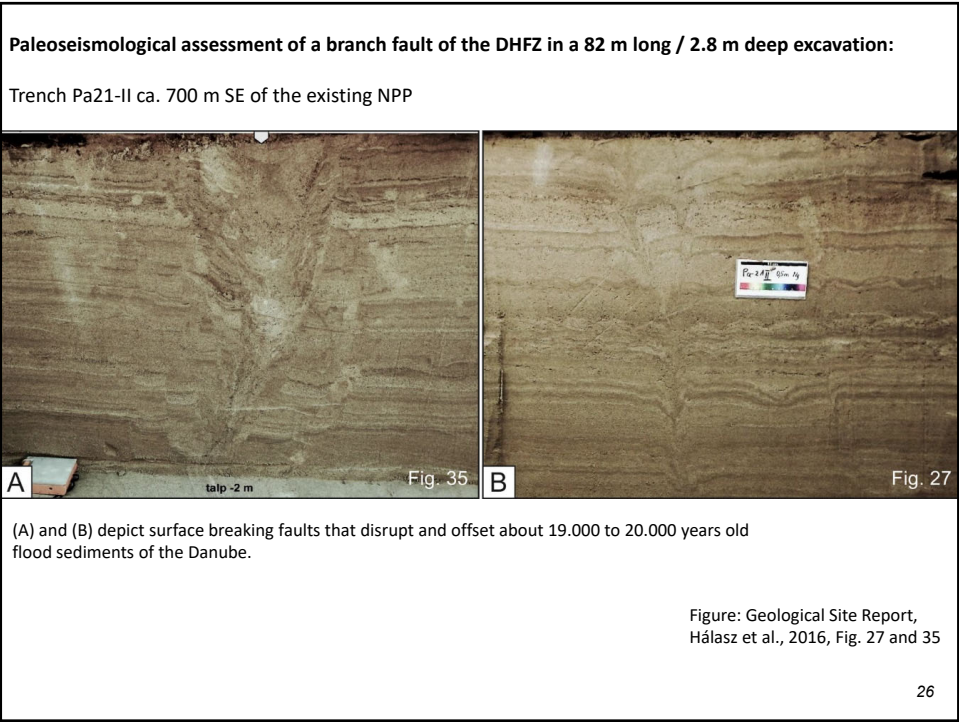
Trench Pa21-II ca. 700 m SE of the existing NPP

The statement is factually wrong. Data in the Geological Site Report prove four surface-breaking earthquakes within a distance of 10 km from the site. Two events with $M > 6$ with ages between 14,000 and 5,000 years were documented in outcrops along Highway M-6 (Magyari, 2016). Two other paleoearthquake ruptures with ages between ca. 19,000 and 20,000 years were documented in trench Pa-21-II next to the site.

Paleoseismological assessment of a branch fault of the DHFZ in a 82 m long / 2.8 m deep excavation:
