APPENDIX 12E: INFORMATION RECEIVED FROM INNOVIA LIMITED

Rev	Date	Drawn	Description	CHK'd	App'd	Title
B	01/07/11	MJG	Positions revised following site meeting	MJG	AKG	Exploratory Hole Location Plan for the Proposed Outline Ground Investigation on the Innovia Site Bridgwater
C	14/07/11	MJG	Positions along W boundary moved 10m from Network Rail Land	MJG	AKG	
D	15/07/11	MJG	SHE Box added	MJG	AKG

Drawn	MJG
Checked	MJG
Approved	AKG
Scale at A1	1:1000
Drawing Number	274077/NOR/304
Rev	Status
B	PRE

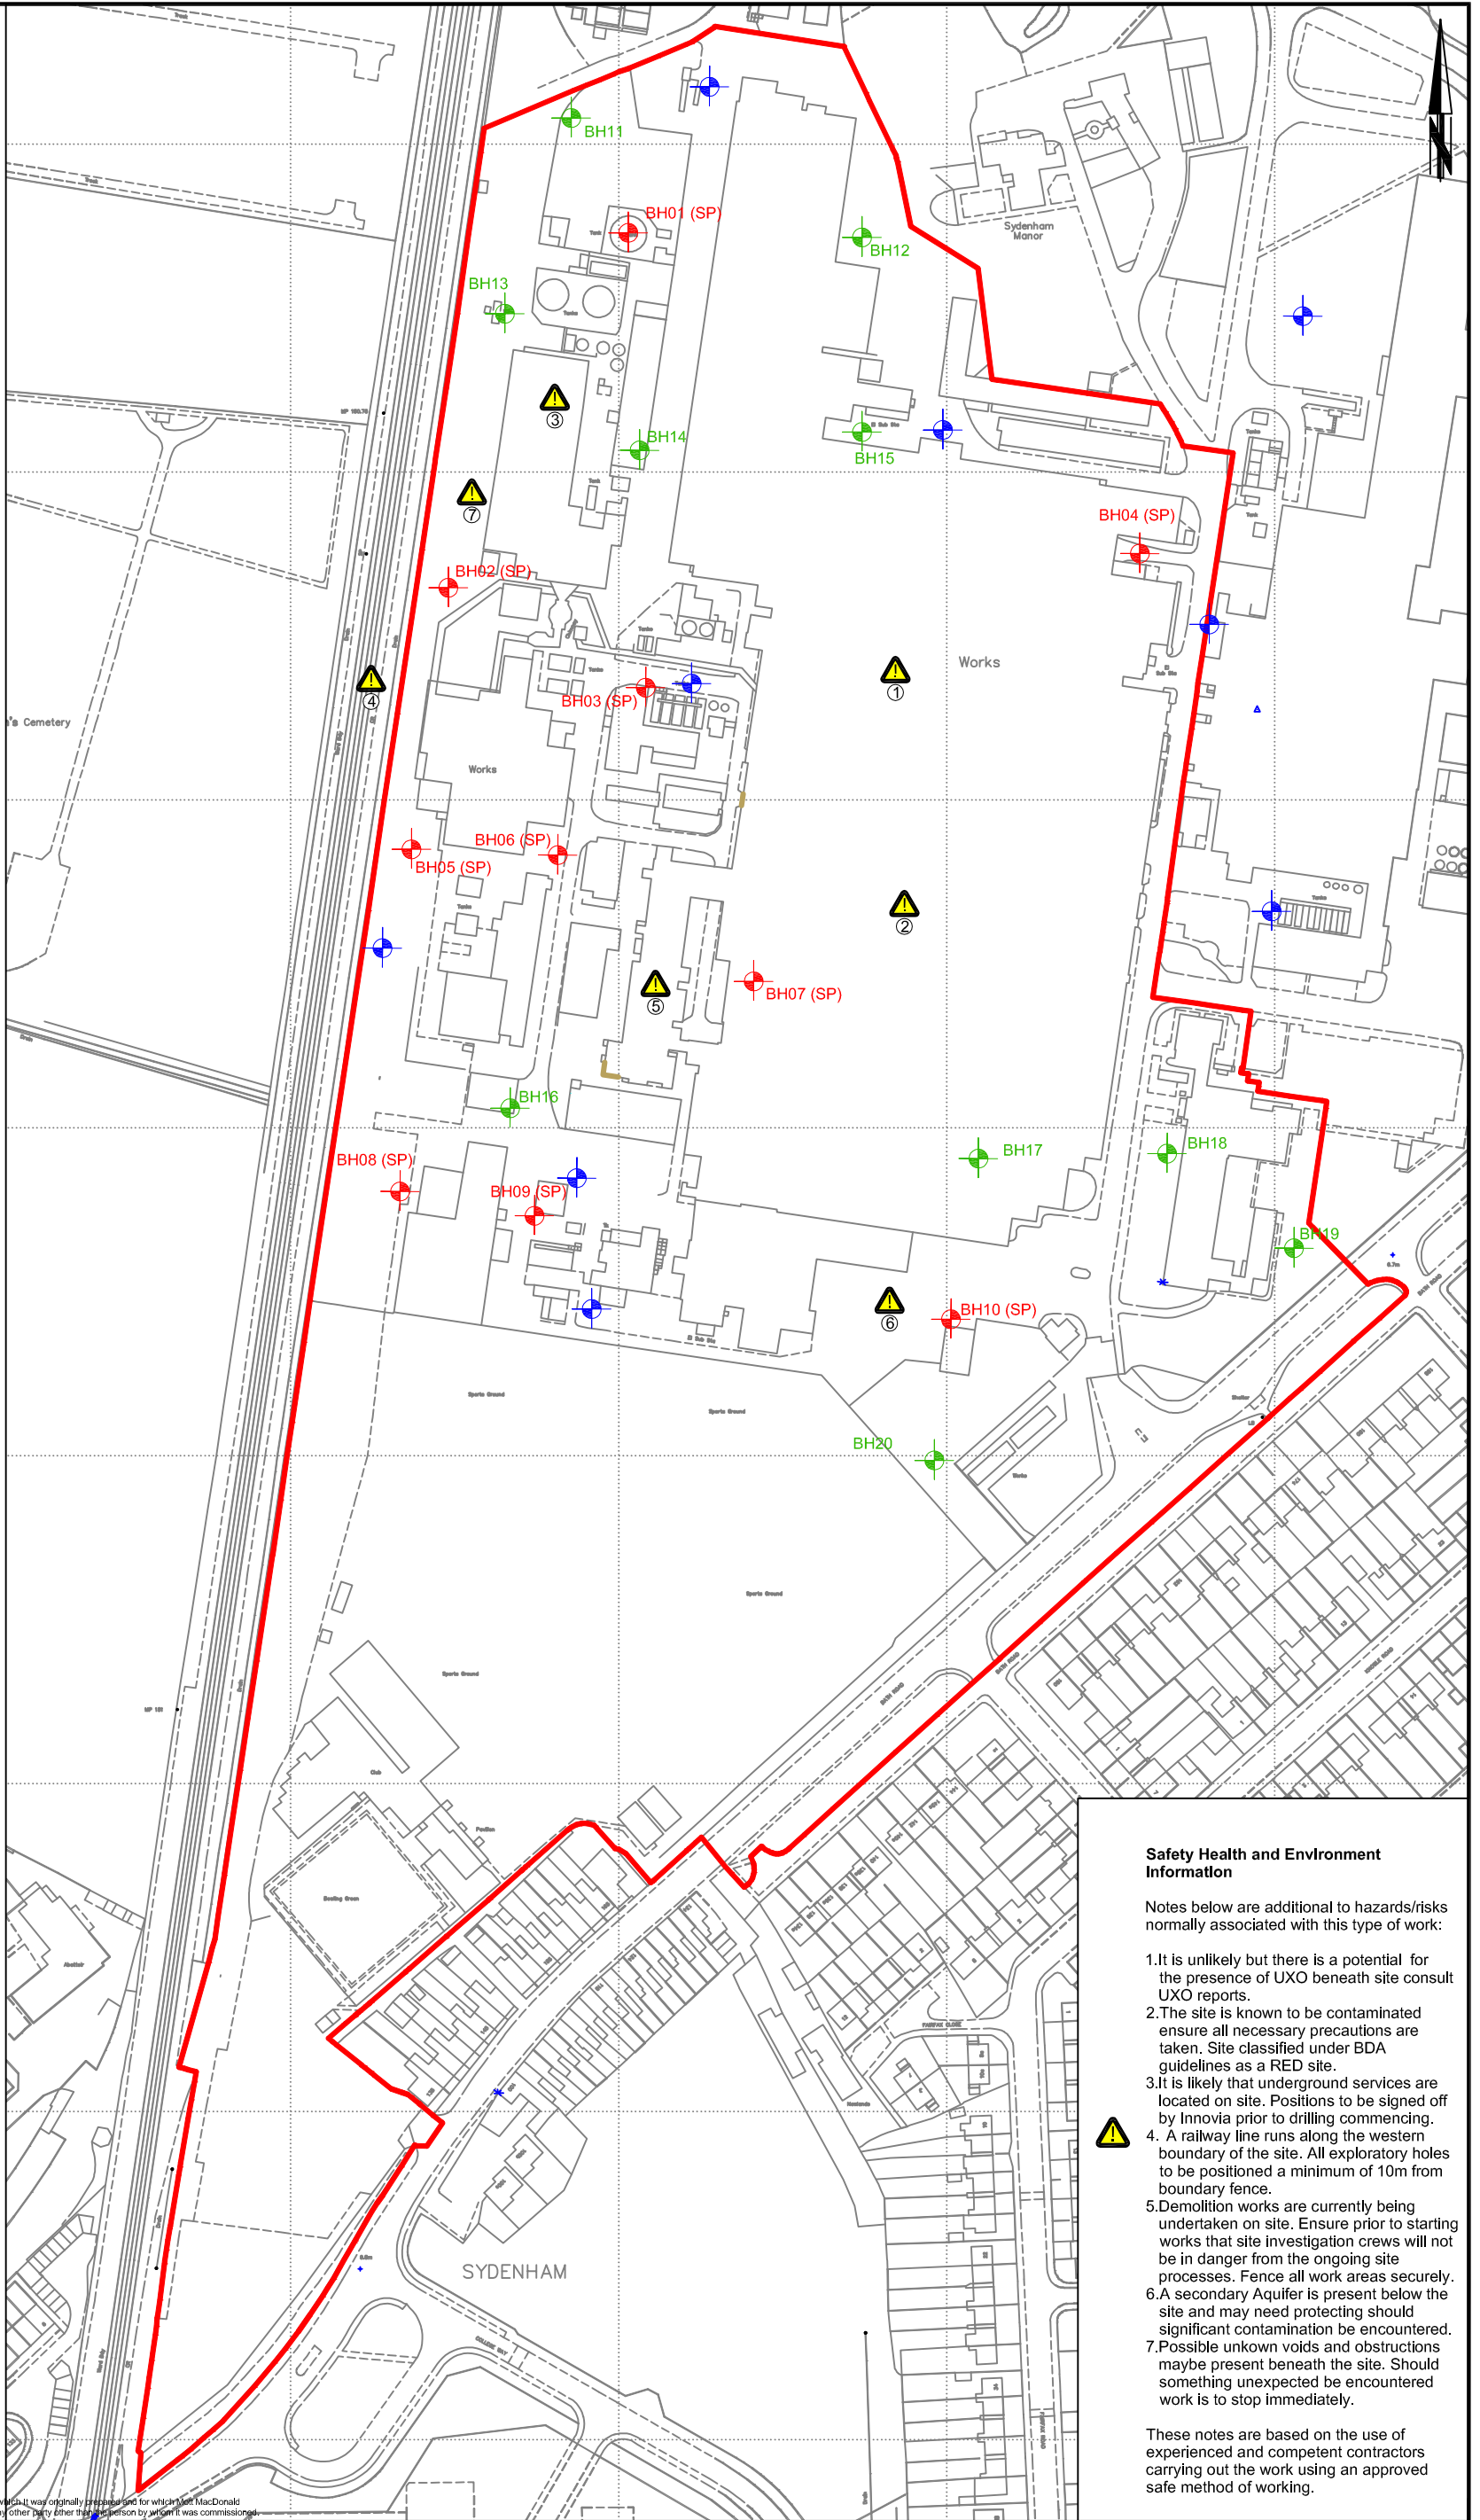
- BH01 Underneath the Old Heavy Fuel Oil Tank and within the area of the previous light fuel oil spillage
- BH02 In close proximity to drains
- BH03 In close proximity to a liquid storage area for Glycols, Glycerine and hypochlorite bleach.

- BH04 In the casting waste area. This could contain a number of different contaminants including Carbon Disulphide, NaOH, H₂SO₄, Sulphides, Bleach, Glycols, Glycerine, Urea.

- BH05 In the solvent recovery area. Likely contamination with spent carbon, itself contaminated with a variety of solvents including Toluene, THF, MEK, Ethyl Acetate.

- BH06 Solvent recovery area- this area is likely to be highly contaminated with solvents as in BH05 and HAS NOT BEEN MARKED IN GREEN.
- BH07 No obvious known problems

- BH08 Old railway unloading sidings and Chemical storage areas. These may contain a variety of monomers including: acrylic acid, acrylonitrile, methacrylic acid, methacrylonitrile,

- BH09 methyl acrylate, methyl methacrylate, hydroxy ethyl acrylate, vinyl chloride and vinyldene chloride. This list is not an exhaustive list of possible chemicals.

- BH10 No obvious known problems
- BH11 Within area of previous fuel oil spillage.
- BH12 In close proximity to drains and oil drum storage area.
- BH13 Live gas main nearby and close to old coal storage area.

- In situ testing to include SPT's, shear vane tests, and piston sampling are to be undertaken in all boreholes.
- Potential standpipe locations (SP) are indicative only and subject to change dependant on findings made during the ground investigation. It is likely only 8 of the 10 holes will be required to have installations.

- All borehole positions along the Western edge of the site to be positioned 10m away from boundary with Network Rail land to prevent drill rig toppling onto Network Rail property.

- Proposed Site Boundary
- Historic Borehole Locations
- Proposed Required Borehole Locations to maximum 35m depth
- Proposed Optional Borehole Locations to 10-15m depth
